NATURAL HAZARDS  
OF  
SAN MIGUEL COUNTY, COLORADO

Report to the San Miguel County Planning Commission

Prepared by Michael J. Bovis

17 May 1976

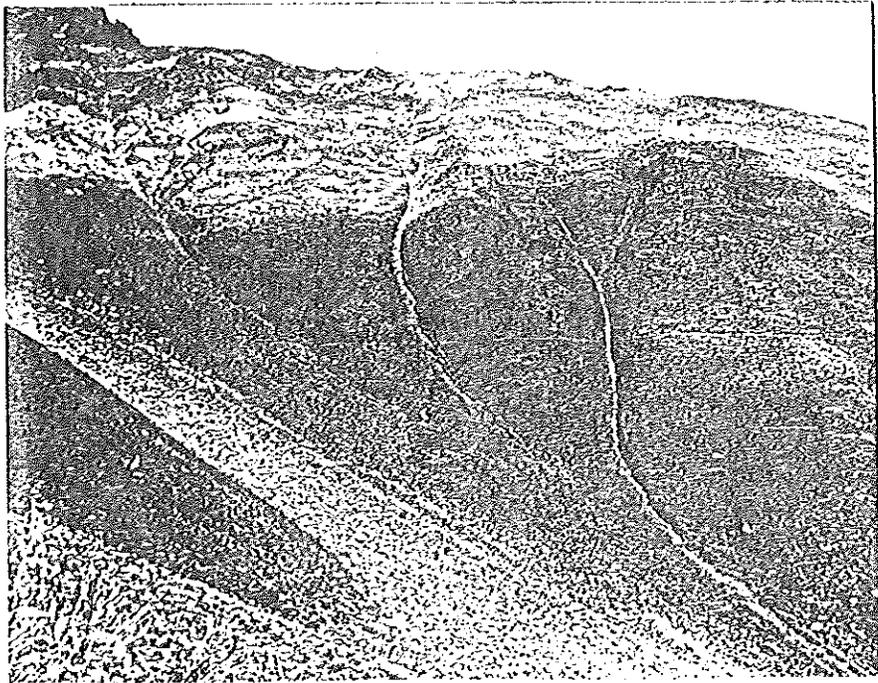
Plate 8: Debris flow tracks in the headstreams of Spring Gulch, above Old Ophir. The main axis of the Gulch is filled with talus material which probably derives from debris flow deposition and talus slides. This picture is typical of many high, alpine basins in eastern San Miguel County that head into volcanic rocks of the Potosi Group.

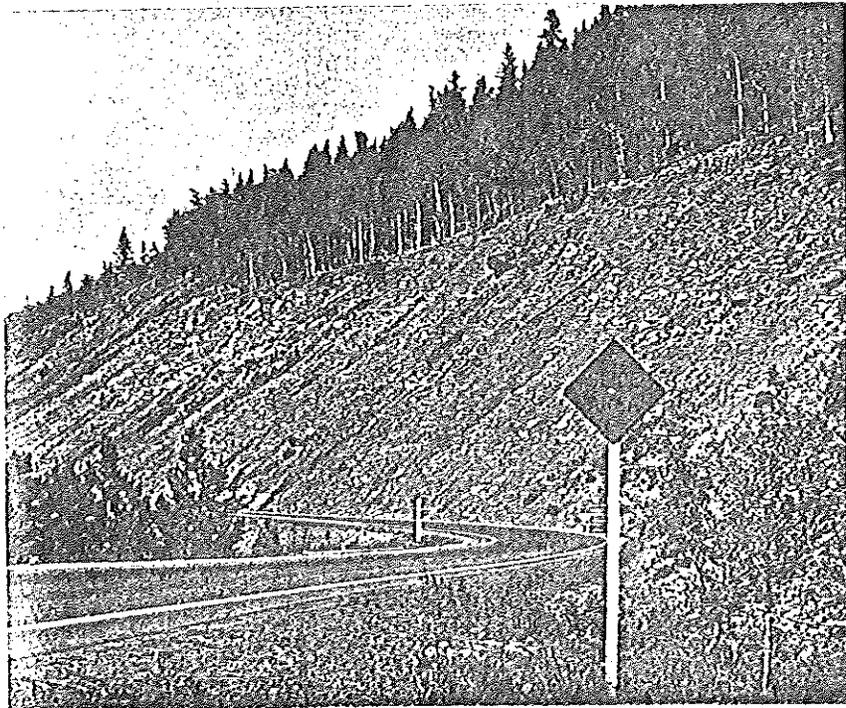
Plate 12: Roadcut in glacial and landslide material, on the west side of the Silver Mountain landslide, just north of Ophir Loop on Highway 145. Some impression is given of the great thickness of the glacial/landslide debris in this area. Disruption of the road surface out of the field of view indicates that deeper seated movement is occurring, in addition to slipping of material on the cut face.

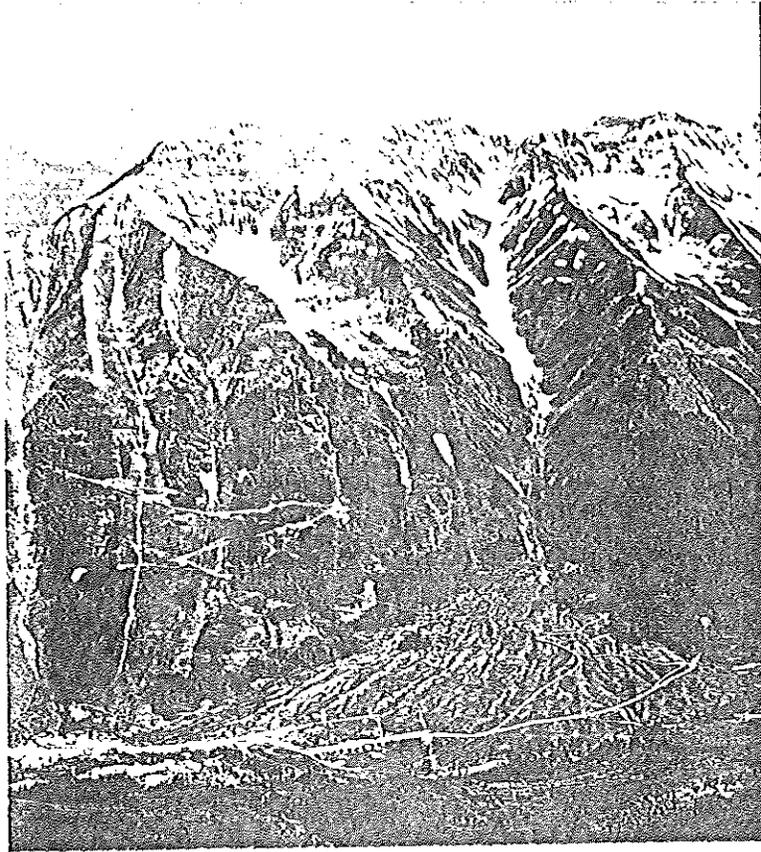
Plate 13: Low-level aerial oblique of Spring Gulch and Staatsburg Basin, on the north flank of Howard Fork. Trimlines in both aspen and coniferous cover are clearly visible at the left part of the picture and demarcate the Badger group of slidepaths. The Spring Gulch avalanche runs onto the large debris fan; just above the apex, a double trimline in aspen is seen, which roughly differentiates large from small avalanches. Avalanche debris from the previous winter follows the axis of the Gulch. The stream course which skirts the right side of the fan is followed, periodically, by large, wet avalanches in spring, yet also have been recorded as traversing the center of the fan to Ophir, the small settlement at the bottom of the picture. Large powder avalanches are thought to impinge on the adverse slope (bottom of picture) about five times each century.

The lighter zones on the debris fan surface are caused by dry soil conditions in the crestal areas of large debris flow levées. From their pattern, it is seen that every part of the fan has experienced debris flow deposition in the past. All of the features are vegetated, yet still preserve the topographic form of levees. The age of the levées is unknown. However, no fresh deposits exist on the fan.

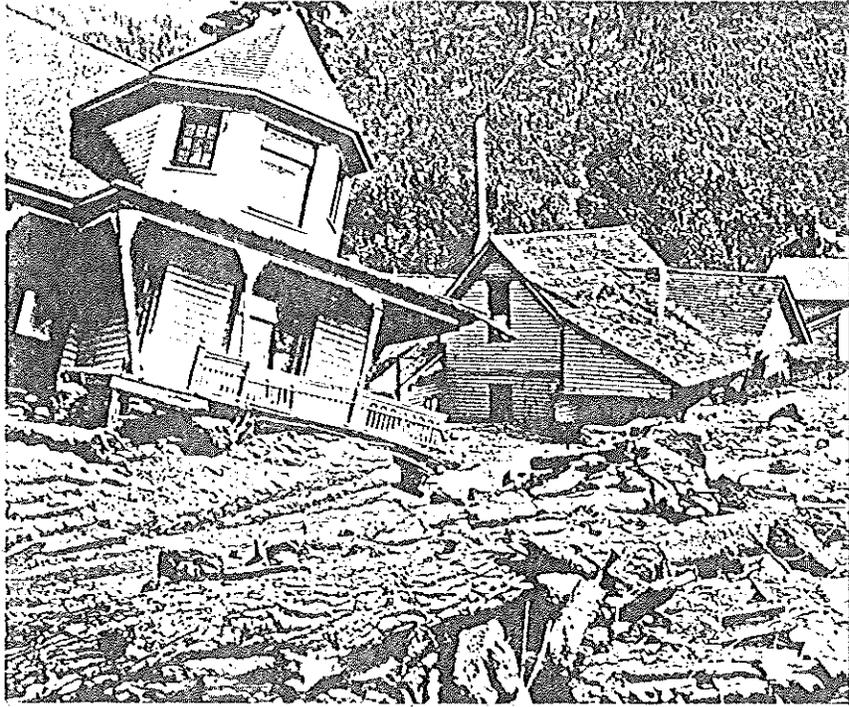
It should not be assumed that fans bearing no signs of recent debris flow deposition are 'safe'. A timely reminder that seemingly inactive debris fans can be affected by events of catastrophic magnitude is provided by the two inundations of the Telluride fan by Cornet Creek in 1914 and 1969. The 1914 event was by far the worst of the two and resulted in extensive structural damage to the town of Telluride (Plate 15). The natural channel of Cornet Creek across the fan has been artificially diverted from its former position on the east side of the debris fan to a location close to its present position on the west side of the fan. The debris flow of 1914, which occurred during a very heavy summer downpour, started in the upper part of Cornet Creek, close to the old Liberty Bell Mine, and descended over 2,000 vertical feet to the debris fan apex. The first slugs of the flow plugged the artificial channel, after which the flow breached the diversion dam and flowed unpredictably across a segment of the fan, which previously, had borne no recent signs of deposition. Extensive damage was sustained by buildings in this sector (Plate 15).

Plate 15: Damage from the 1914 debris flow inundation of Telluride by Cornet Creek. The peculiar character of debris flow material enables it to support the weight of large blocks of rock, which may inflict considerable damage to structures. The photograph was taken after the debris had been cleaned up, so that the pile in the foreground is not the terminal surface of the original debris flow.  
(Photograph courtesy of the San Miguel County Museum, Telluride).

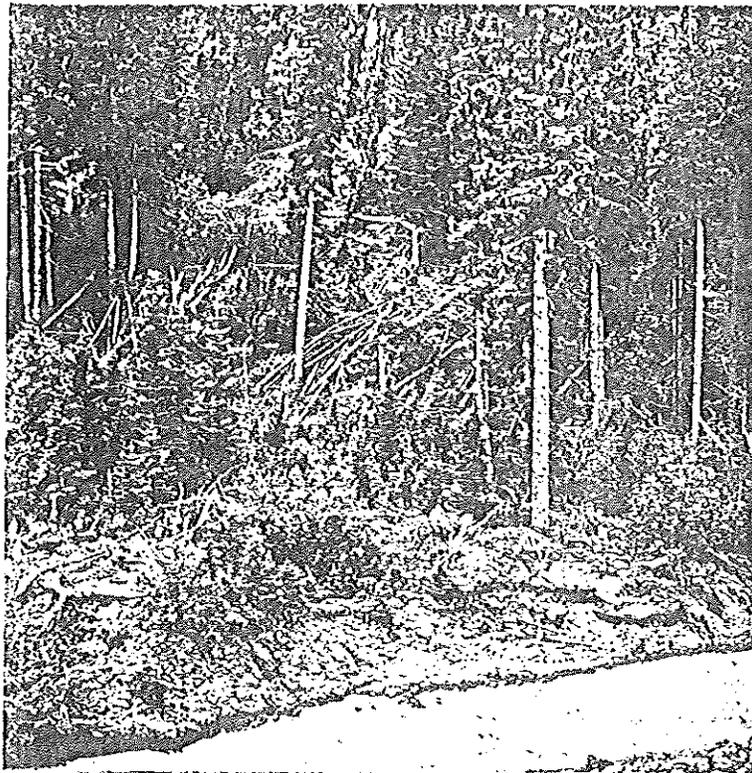
Plate 17: Avalanche impact damage from dry avalanches on the adverse slope of the Spring Gulch avalanche path, at Ophir (See Plates 13 and 16 for the general setting). Limbs have been trimmed from the sides of the trees exposed to impact and many trees have been felled on the adverse slope. This is clear evidence of periodic avalanche activity on a large scale.
