The 2010 work plan for Lewis Mill addressed safety issues, exterior weatherization, and some interior structural stabilization. This photo was taken prior to the start of the 2010 work season.

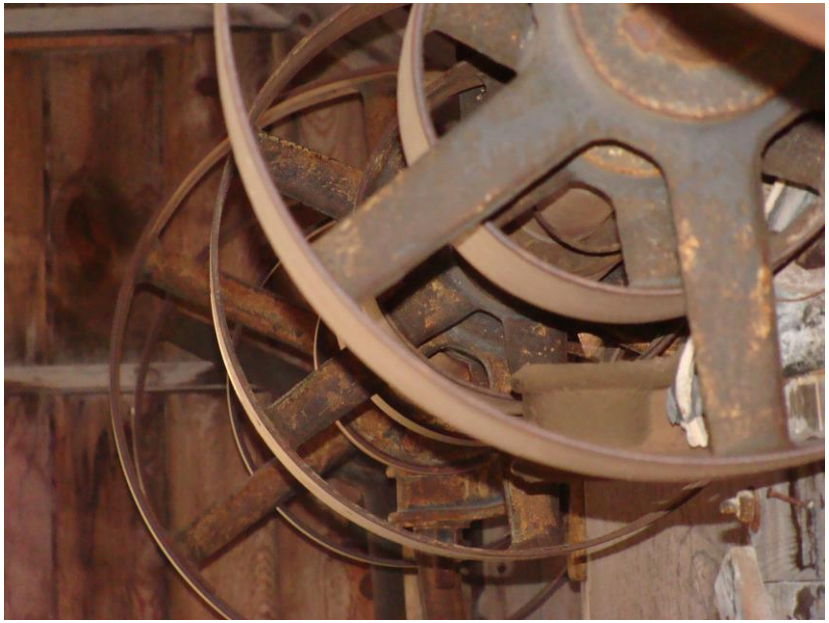
The photo on the right shows collapsed equipment and support timbers. As the heavy equipment gives way to gravity and support timbers collapse, the building is destabilized. The project included conveyor wheel structure repair and stabilization of the 50 foot tall conveyor belt shaft.

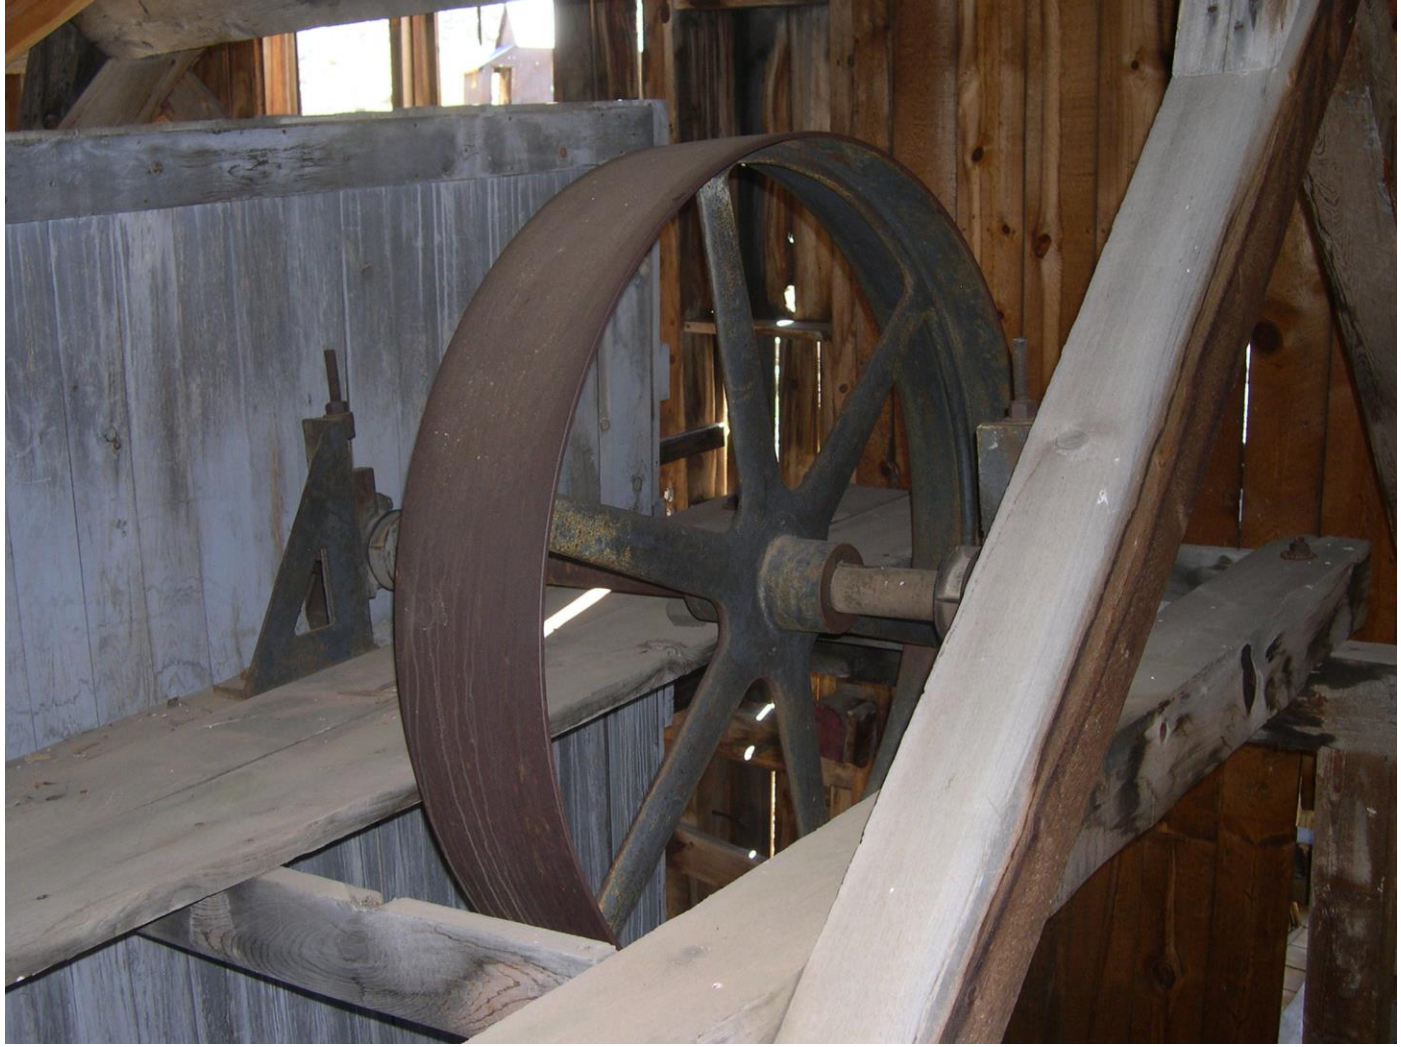
Conveyor Wheel Structure Repair. A conveyor belt system runs throughout the building. As depicted in this photo the wheels in the upper tier of the mill listed east by more than 20 degrees. The timber support system was rotten and in danger of collapse. Major structural timbers that supported large steel wheels in or near the conveyor belt shaft had to be stabilized.

Photo left is a rotten structural support for the conveyor belt wheel. Photo right is the stabilized structural support for the conveyor belt wheel.
