# Fort Peabody Guardhouse

A Historic Preservation Project conducted by San Miguel County with authorization from and direction by the GMUG National Forest personnel in 2010. Fort Peabody was nominated by MaryJoy Martin and listed on the National Register of Historic Places. The site represents labor history in the West.

# Planning for work on the Fort Peabody Guardhouse work began in 2007.

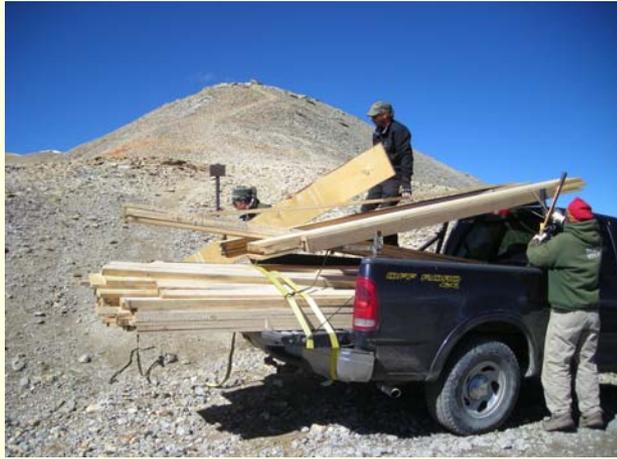
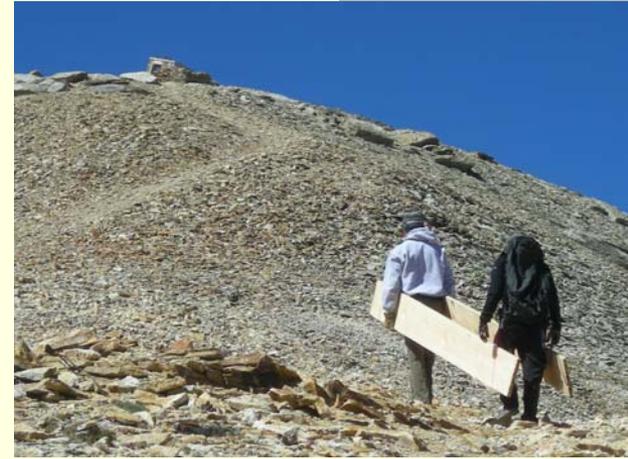
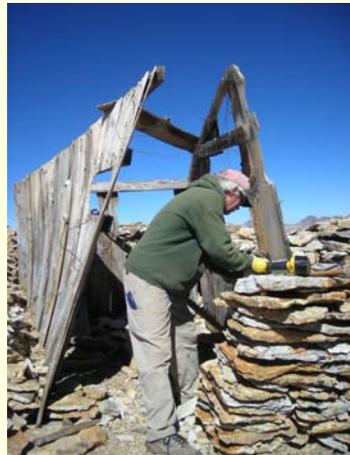
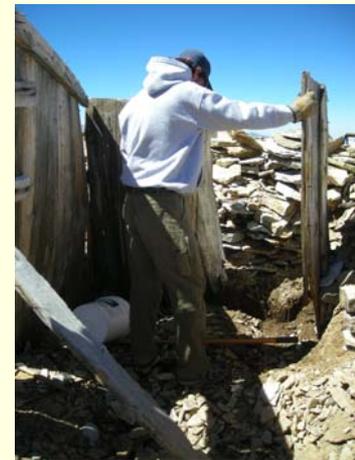
# 2010 Work in Progress

All materials and tools were carried up to the site by hand.

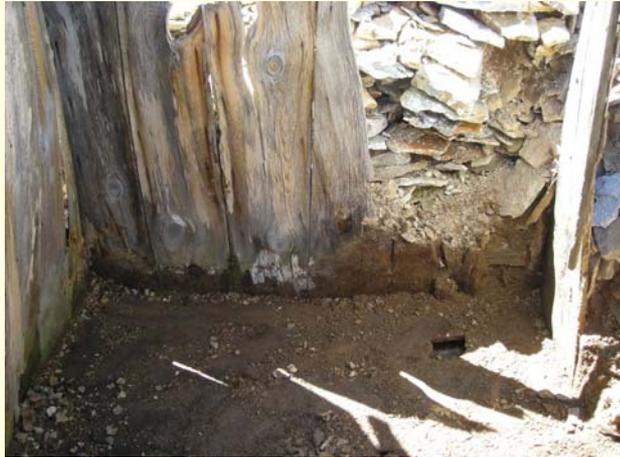
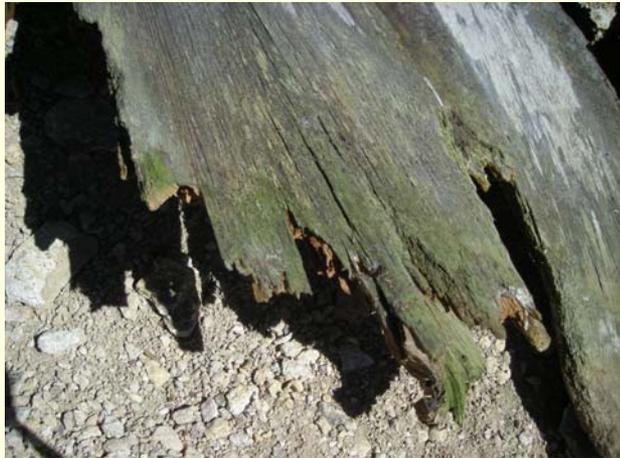
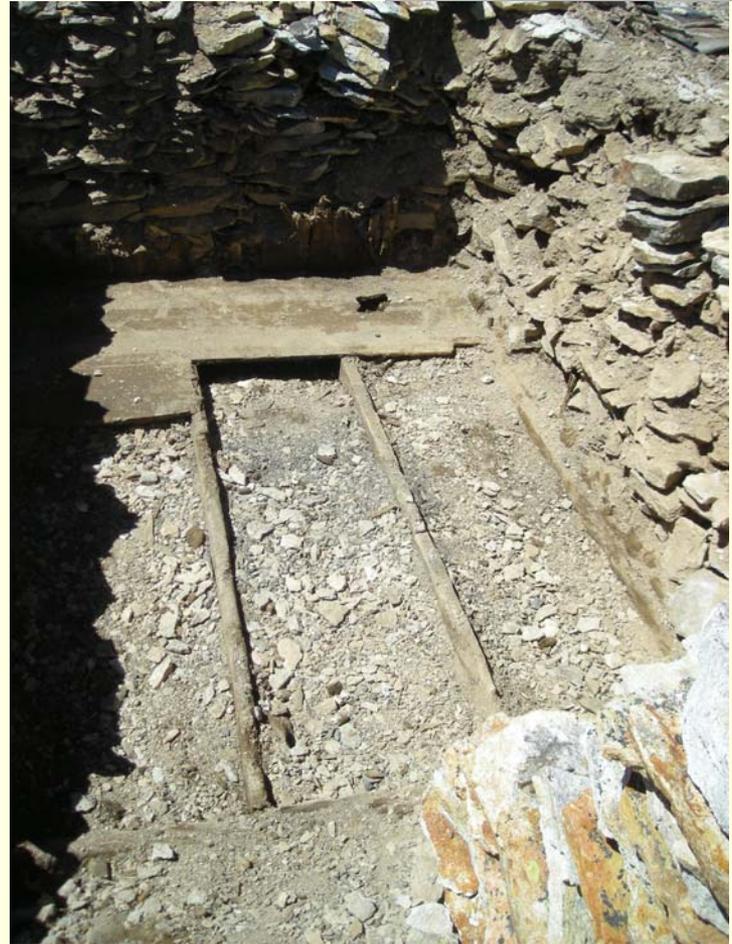
# Excavation of Fort Peabody Guardhouse 2010

After excavating down to the original wood floor, the work crew discovered that most of the boards were rotten where the boards and battons connected with the floor.

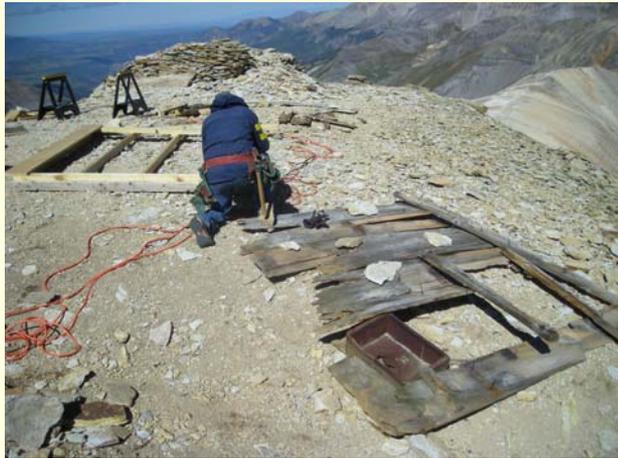
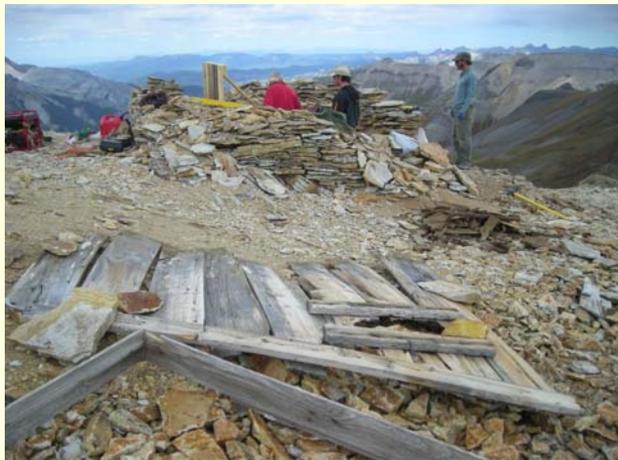
# 2010 Fort Peabody Historic Re-build

- All of the historic boards, battons, and hardware were saved and re-used when possible.
- The majority of century old boards were deteriorated and could not be re-used.
- Every effort was made to restore the structure to historical standards.

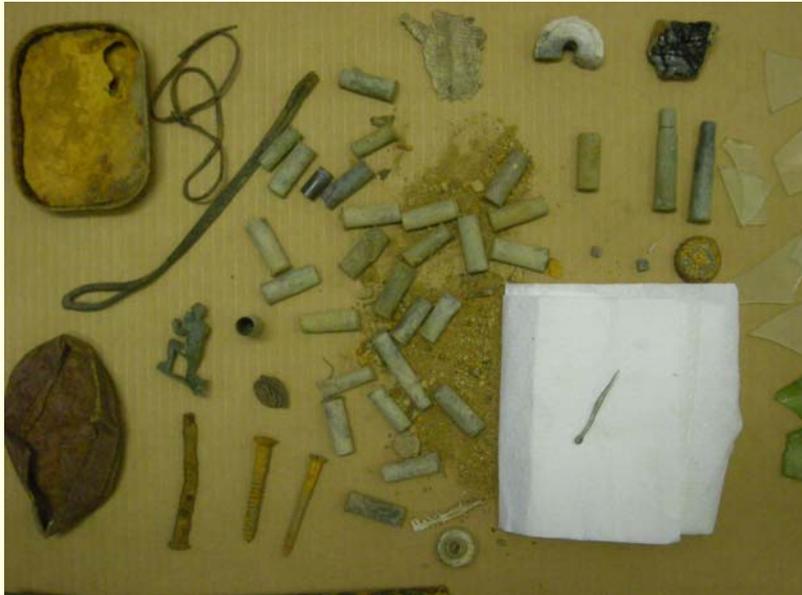
# 2010 Artifacts Excavated from Site

- During excavation of Fort Peabody, the work crew found numerous ammunition shells, a silver hair pin, an old piece of newspaper, coal, leather pieces, glass fragments, and a fire poker. All artifacts were turned over to the USFS.

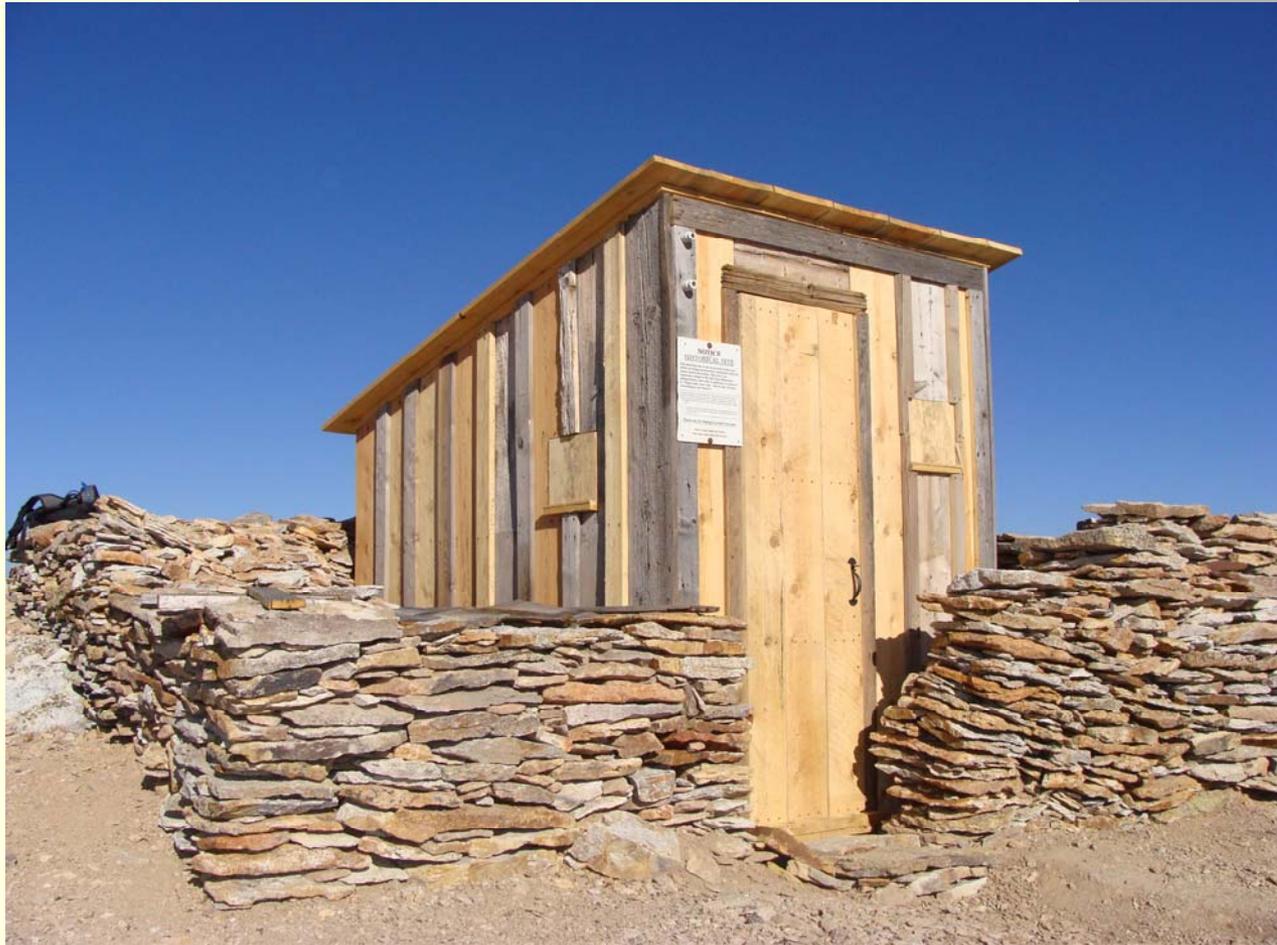
# 2010 Front Door and South Wall Detail

Completed project includes new door with historic hinges and thumb latch. Window shutters were added to protect structure from the elements. Rock wall was re-stacked to replicate the original wall.

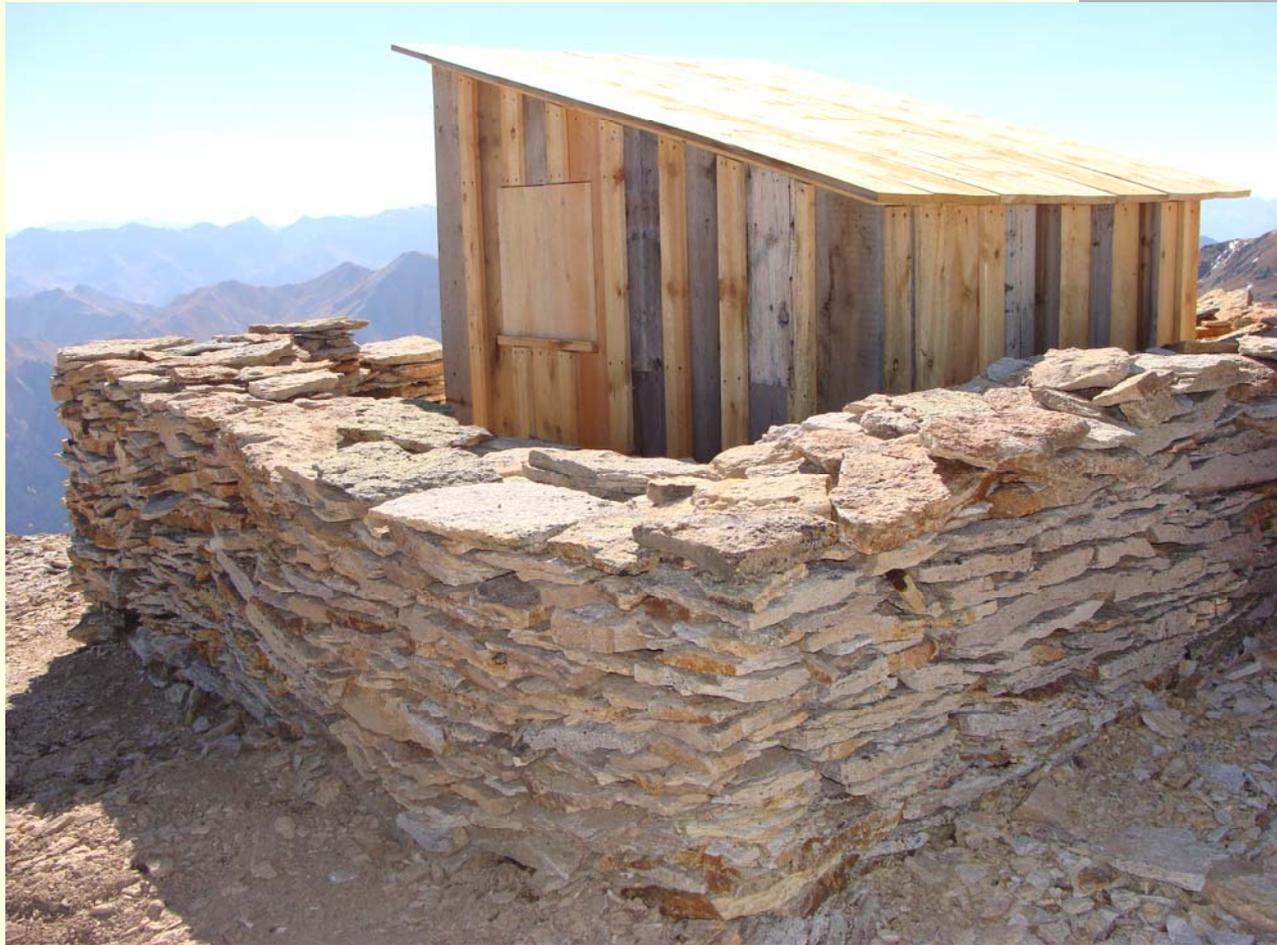
# 2010 Fort Peabody Northwest View

The original wood was mixed in with rough cut pine. All new nails were soaked in acid prior to construction to produce a more historic look.

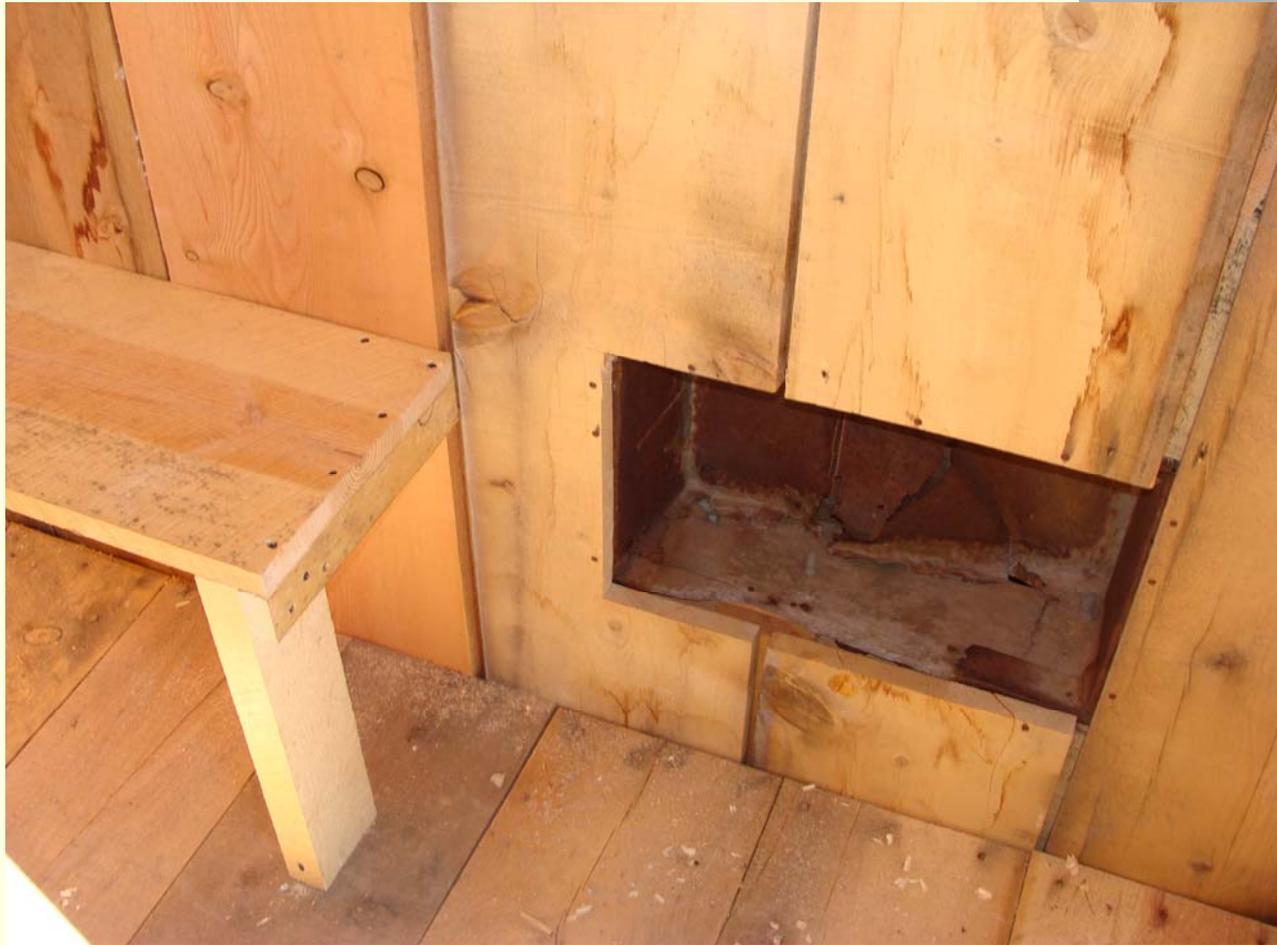
# 2010 Fort Peabody Interior Detail

A historic bench was re-built and a storage compartment was installed in its original location. The rough cut floor acts as the foundation for the walls and stabilizes structure.

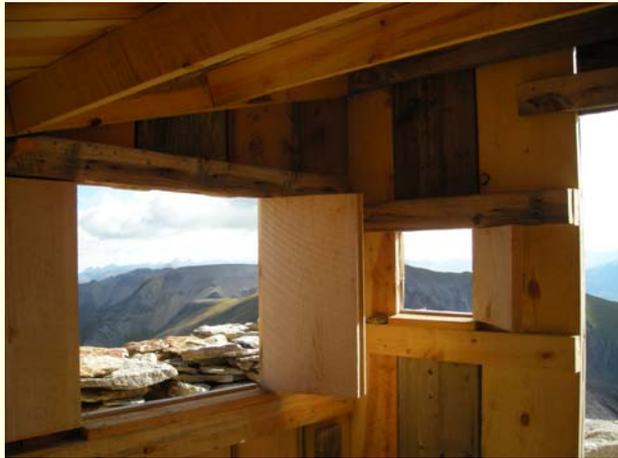
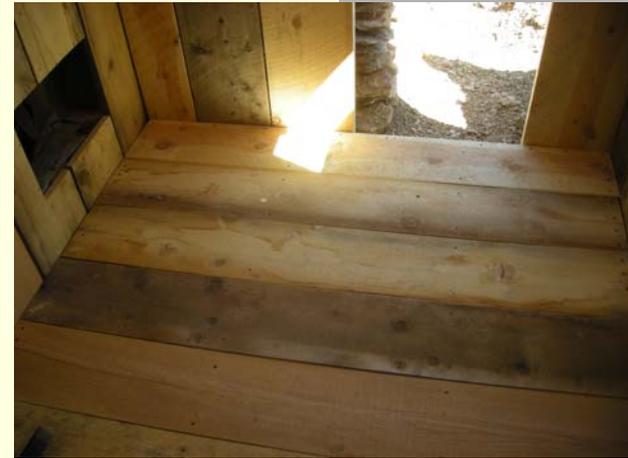
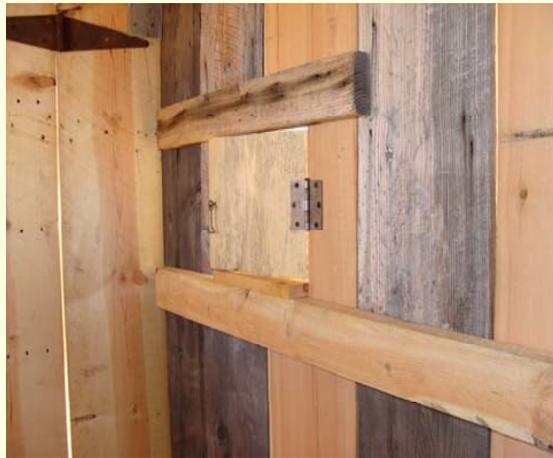
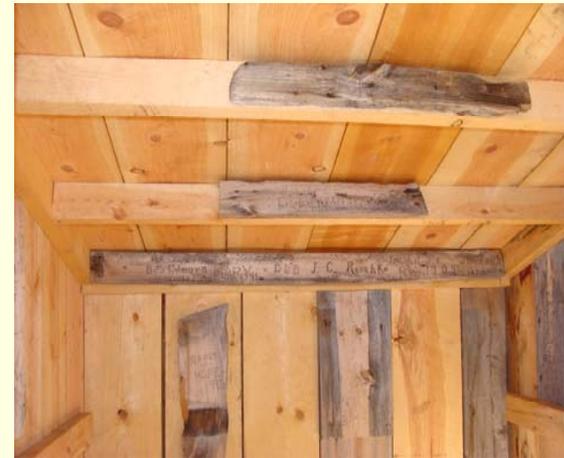
# 2010 Interior Detail

All boards with historic graffiti where saved and applied to the interior of the guardhouse.
